**A Historical and Architectural Study of
Three Rustic Structures at Giant Forest in Sequoia National Park
The Market, District Ranger's Residence, and Comfort Station**

Prepared by
C. Craig Frazier and Craig A. Kenkel
Historical Architects

**HISTORIC STRUCTURES REPORT
SEQUOIA NATIONAL PARK**

Approved
December 7, 1988

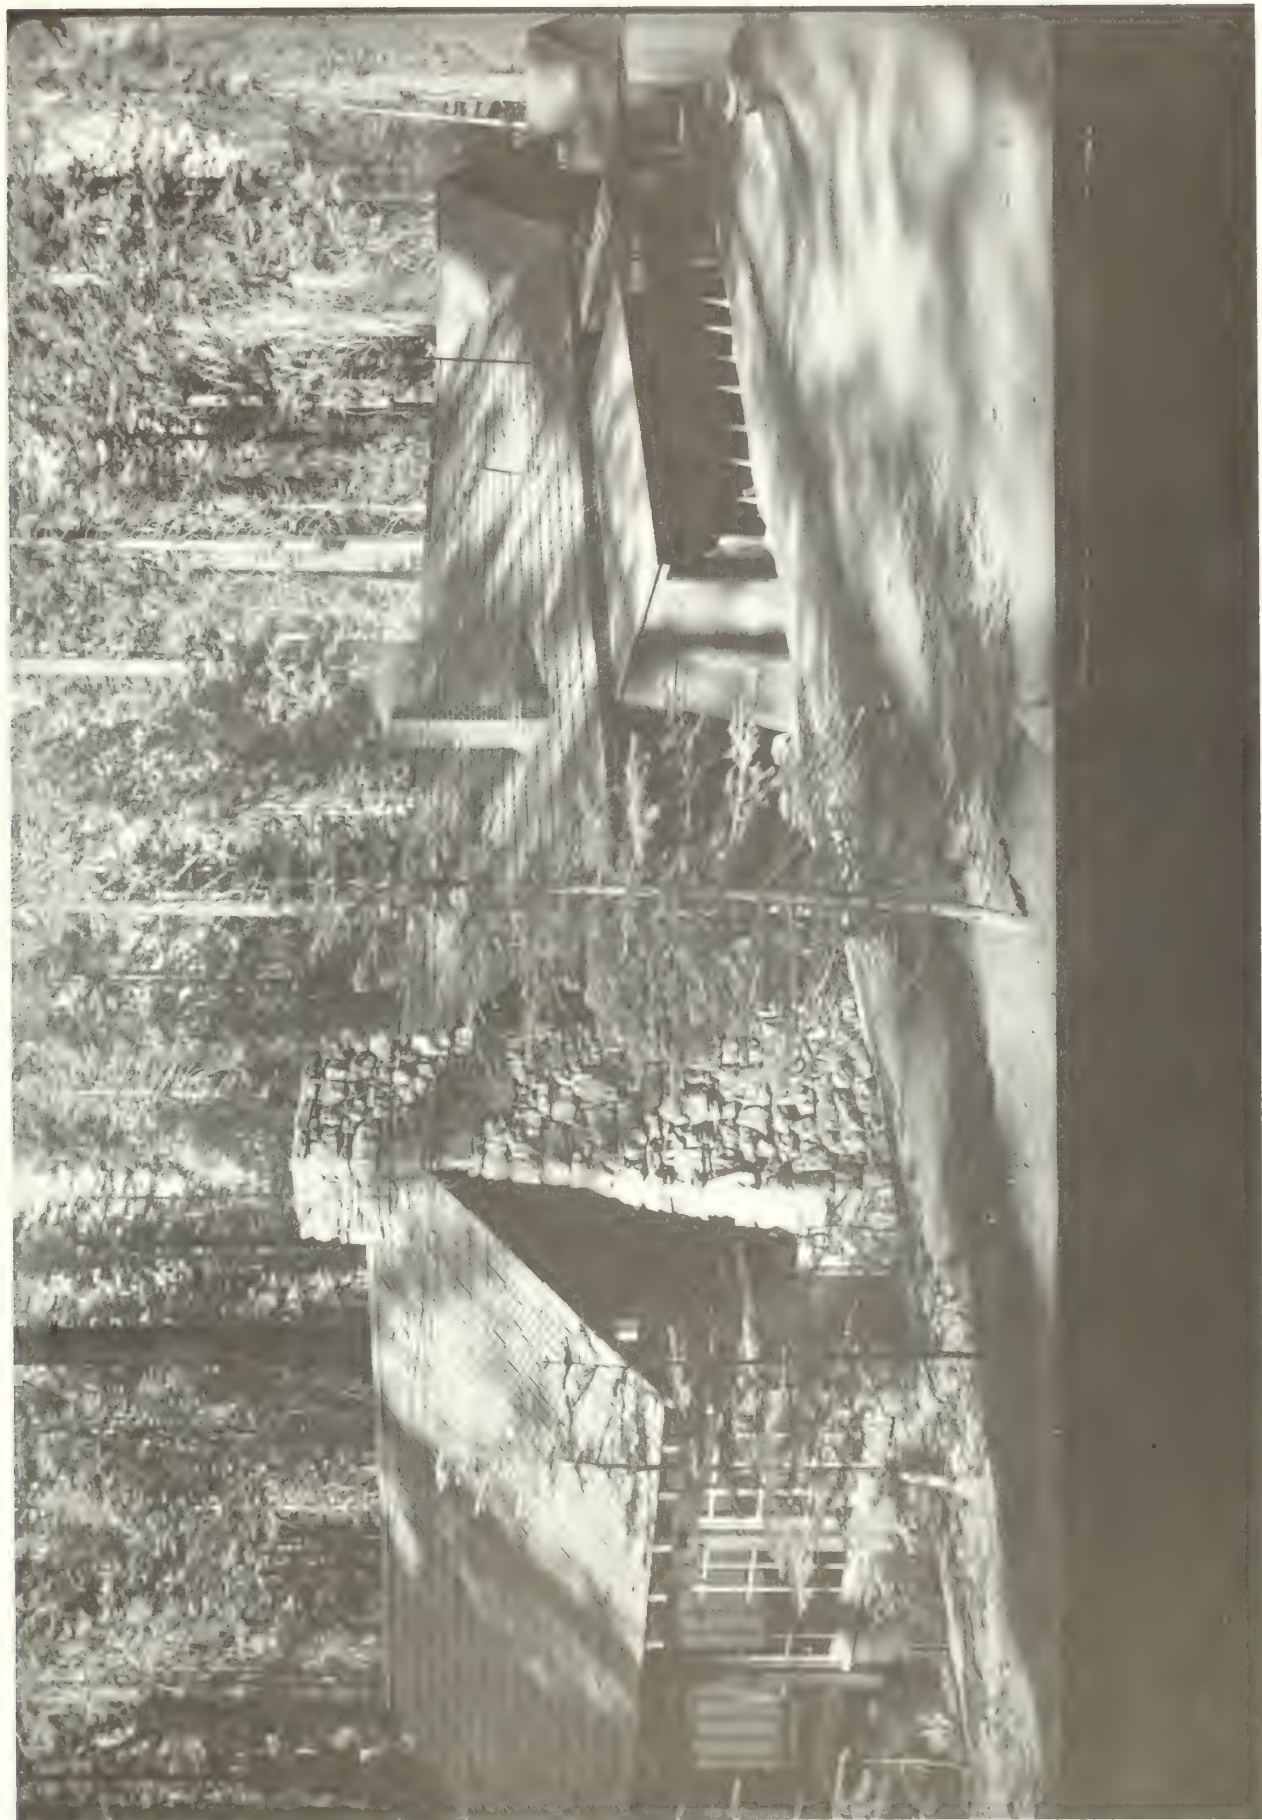
Figure 21. Market, View of Rear (west) Side (1935). This is the first known photograph showing the back of the market and the only known view of the first shed roofed addition. Electric power lines connect at the south wing. A brick chimney is present (no longer extant). The first shed addition appears to be protected along the west by a retaining wall and a door is present at its south end (features proposed in this HSR for installation at the 1938 addition). Notice the level of site grade adjacent to the south facade is much lower than today and probably allows the proper functioning of the crawl space vents which are now buried (Photo by Lloyd Fletcher, SEQU archives #05185).

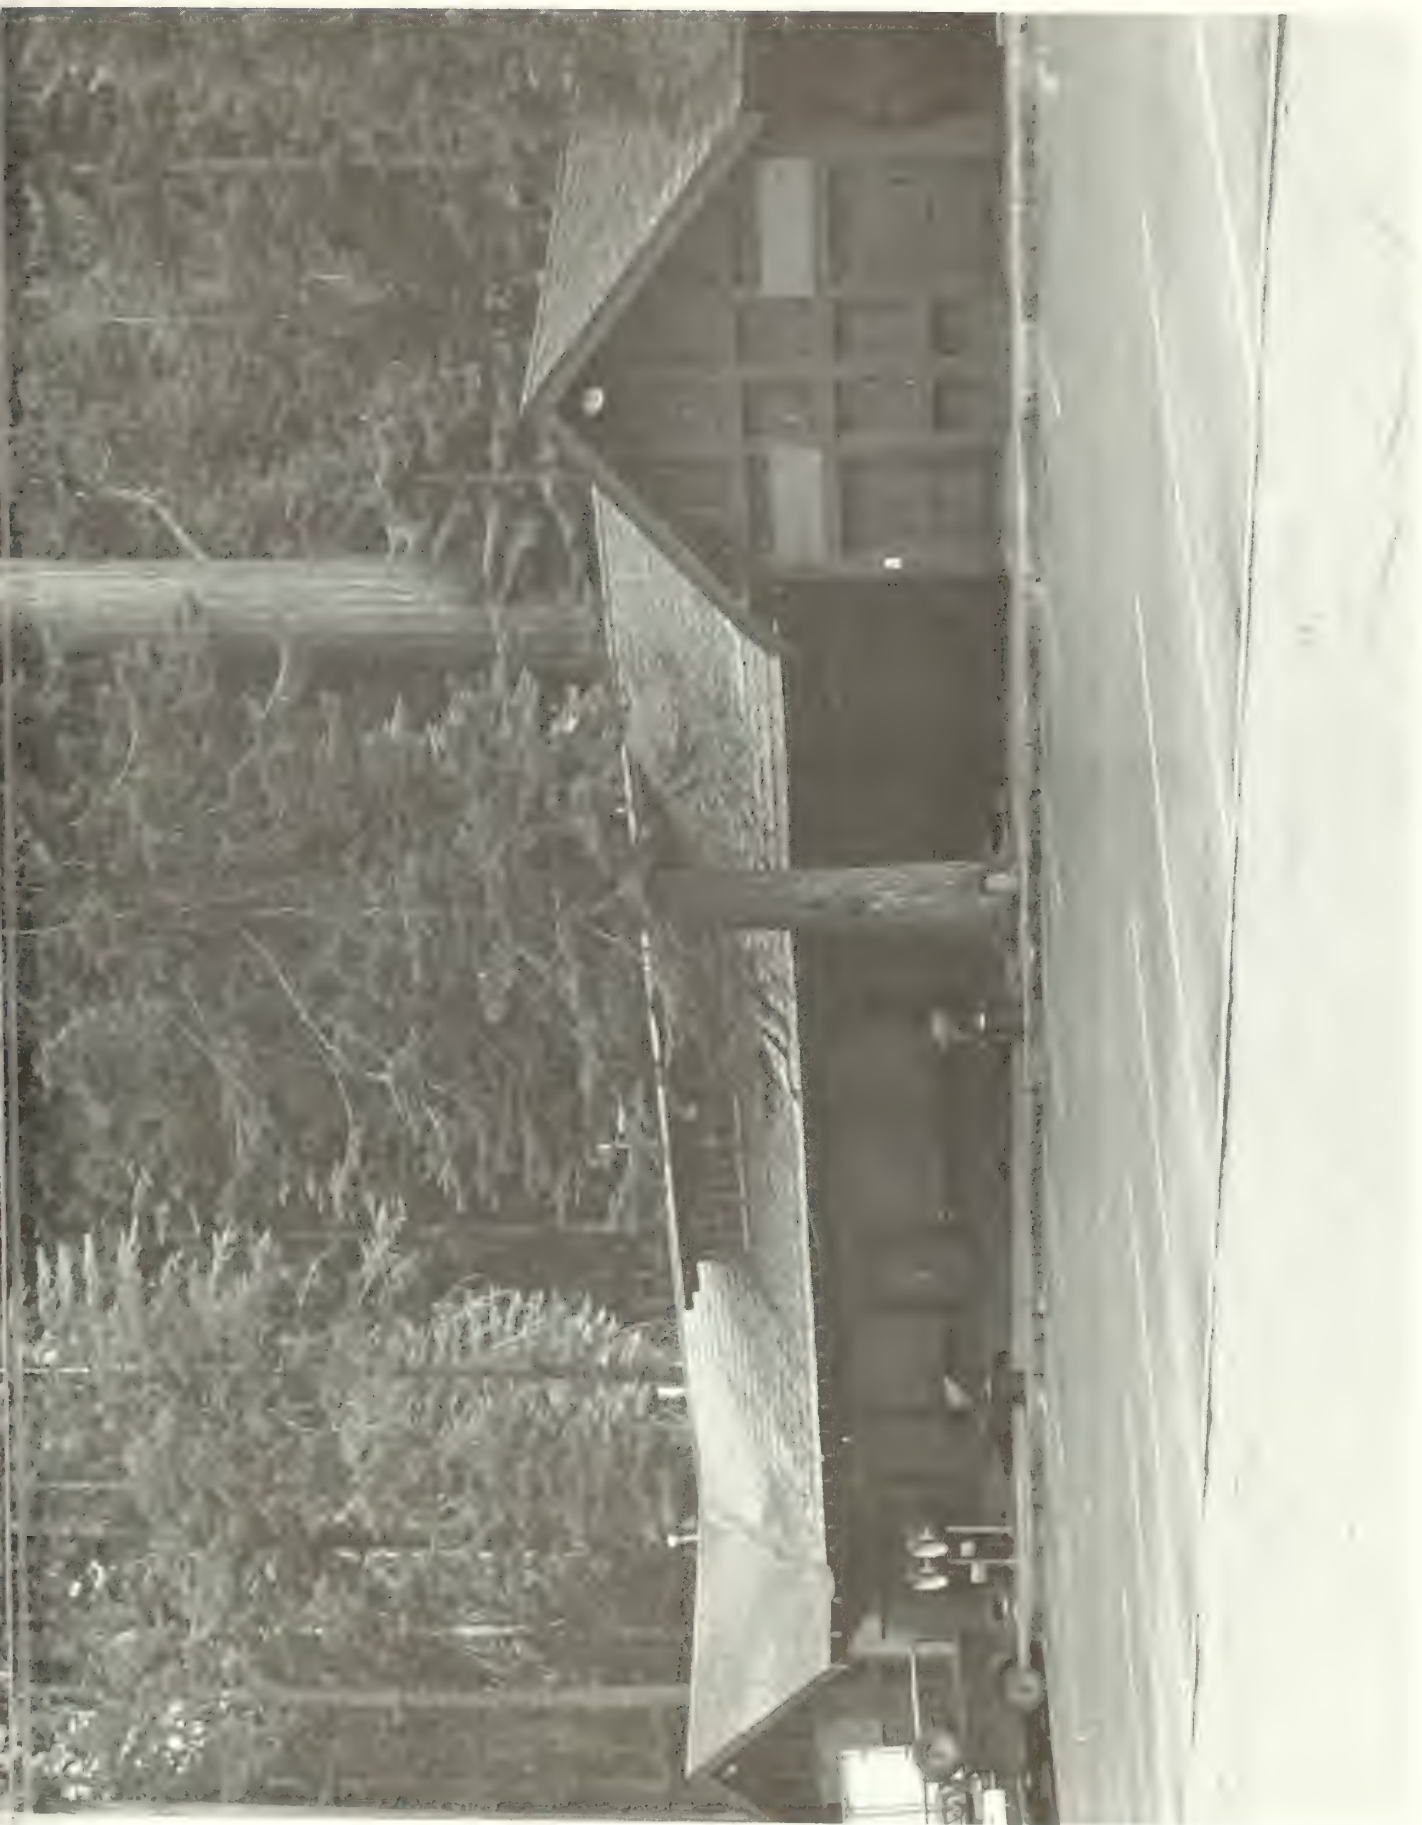
Figure 28. Market, View from West, Southwest (1973). Apparently shut down at this time, this view includes several aspects of interest compared to the previous view (1947): gable end lamps have been relocated to below the roof overhang; signs are gone; wooden ramps approach two doors; and the deteriorated roof is a major subject of the 1973 photographs. Of note is the partial replacement of shake roofing with wooden shingles at the north end. (Photo by Bill Jones, SEQU archive collections)

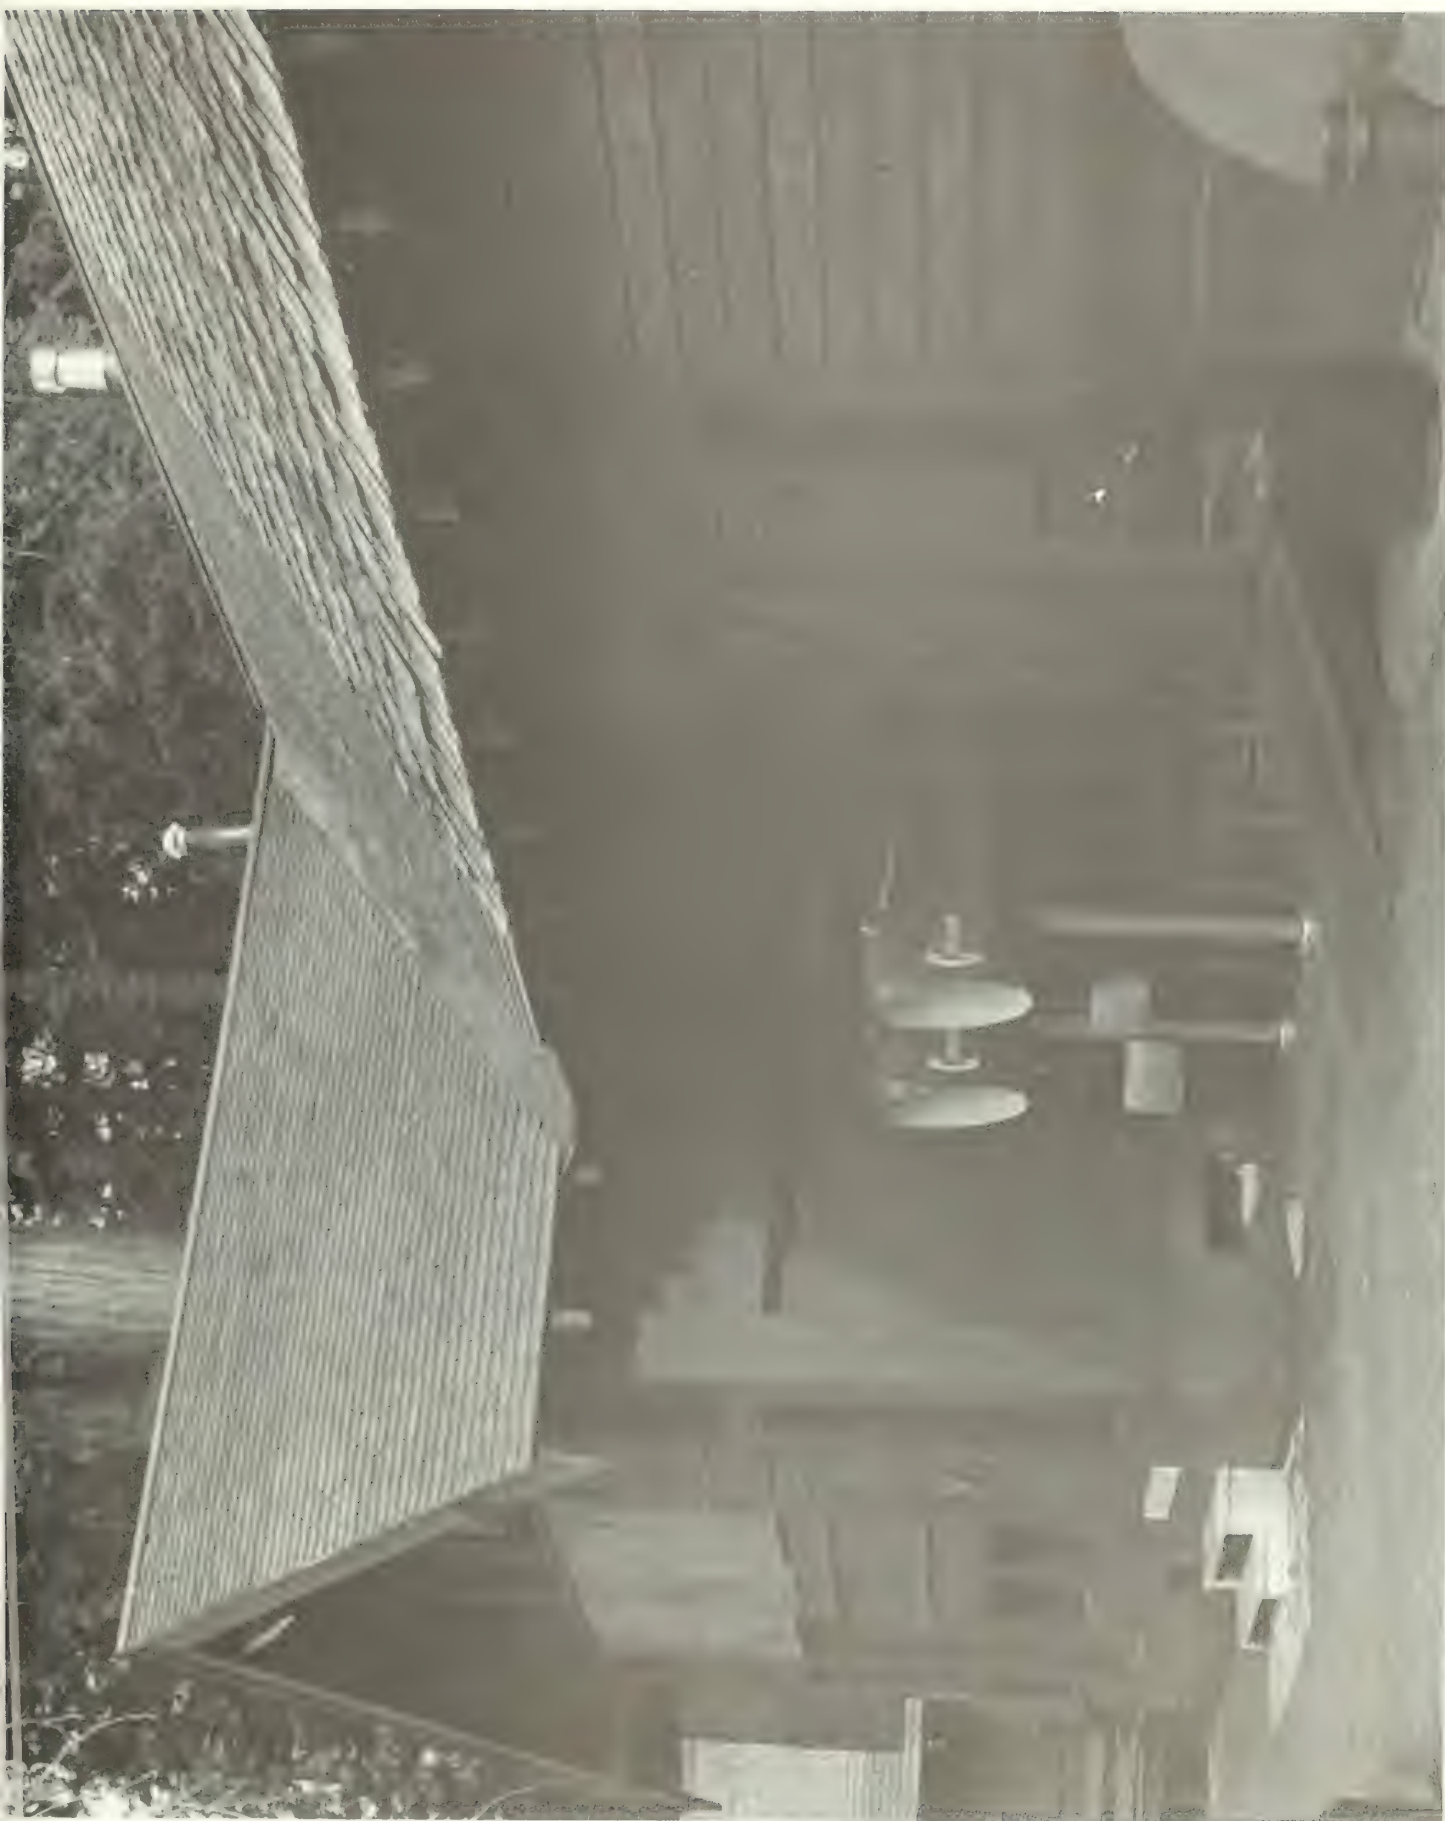
Figure 30. Market Detail (1973). Concrete pads were placed for trash can, telephone and stair bases. Notice ramp to door not presently in use. This detail shows a portion of the shakes replaced with wood shingles; a significant textural change. (Photo by Bill Jones, SEQU archive collection)

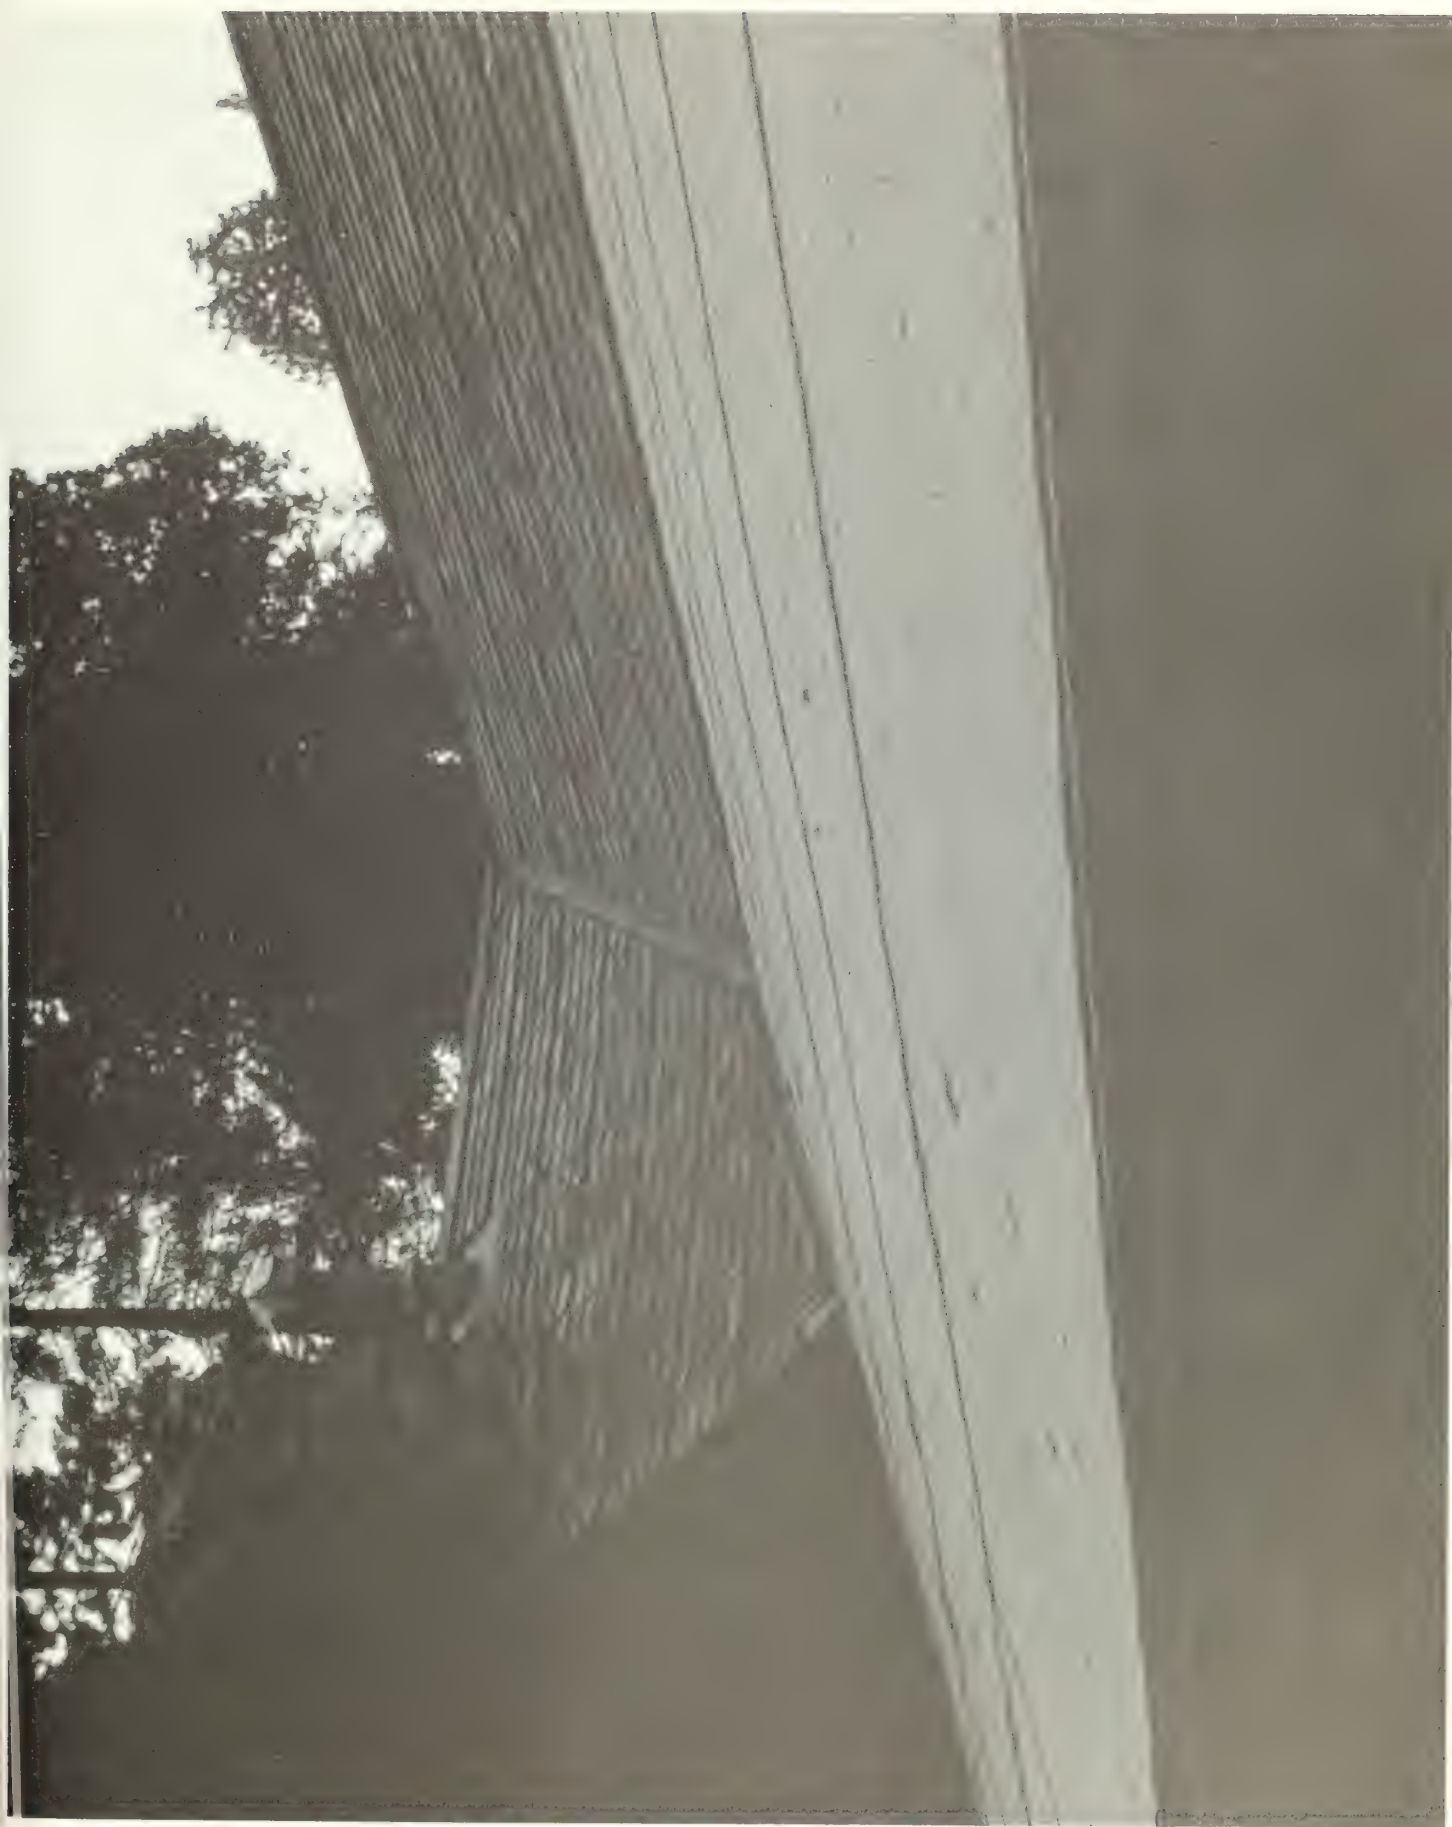
Figure 31. Market Roof Detail (1973). This view shows that the 1938 shed roofed addition had only roll roofing (no shingles). Notice the main market roofing is of wooden shingles which include double shingles at every fifth course. The northern facing leaf of the north wing gable, too, was replaced in this style (Photo not reproduced here). The original shake roof was replaced on these roof leaves. (Photo by Bill Jones, SEQU archive collection)

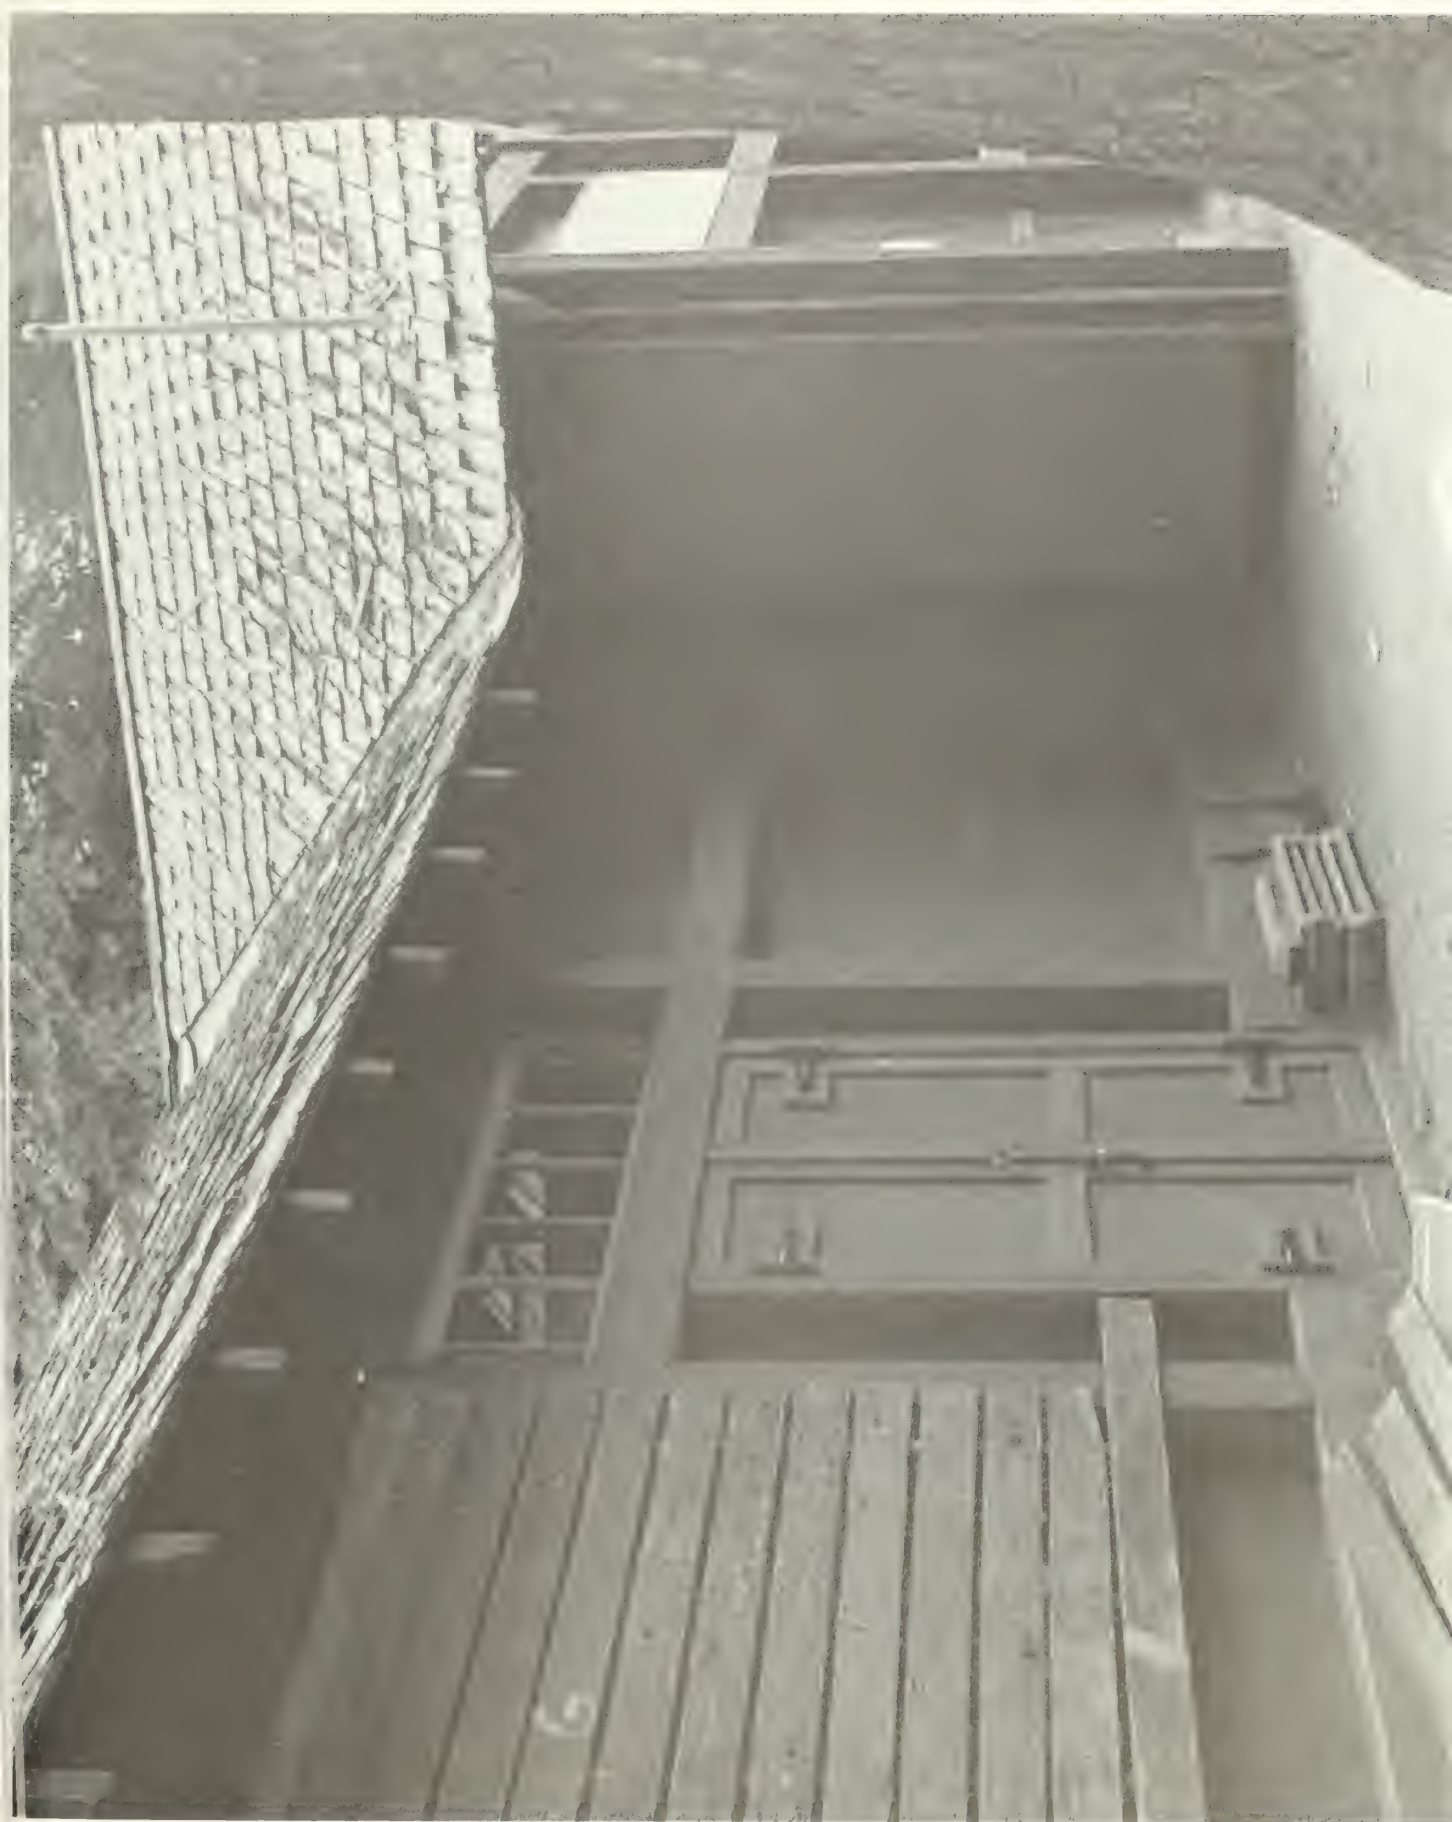
Figure 32. Market Detail at West (1973). The condition and design of the original shake roof is clearly seen here. The gas manifold cabinet, at right, was installed by this period. Notice the present elevation coating of asphalt pavement has yet to be placed and that the crawl space vent is exposed by a depression in the earth walk. (Photo by Bill Jones, SEQU archives collection)

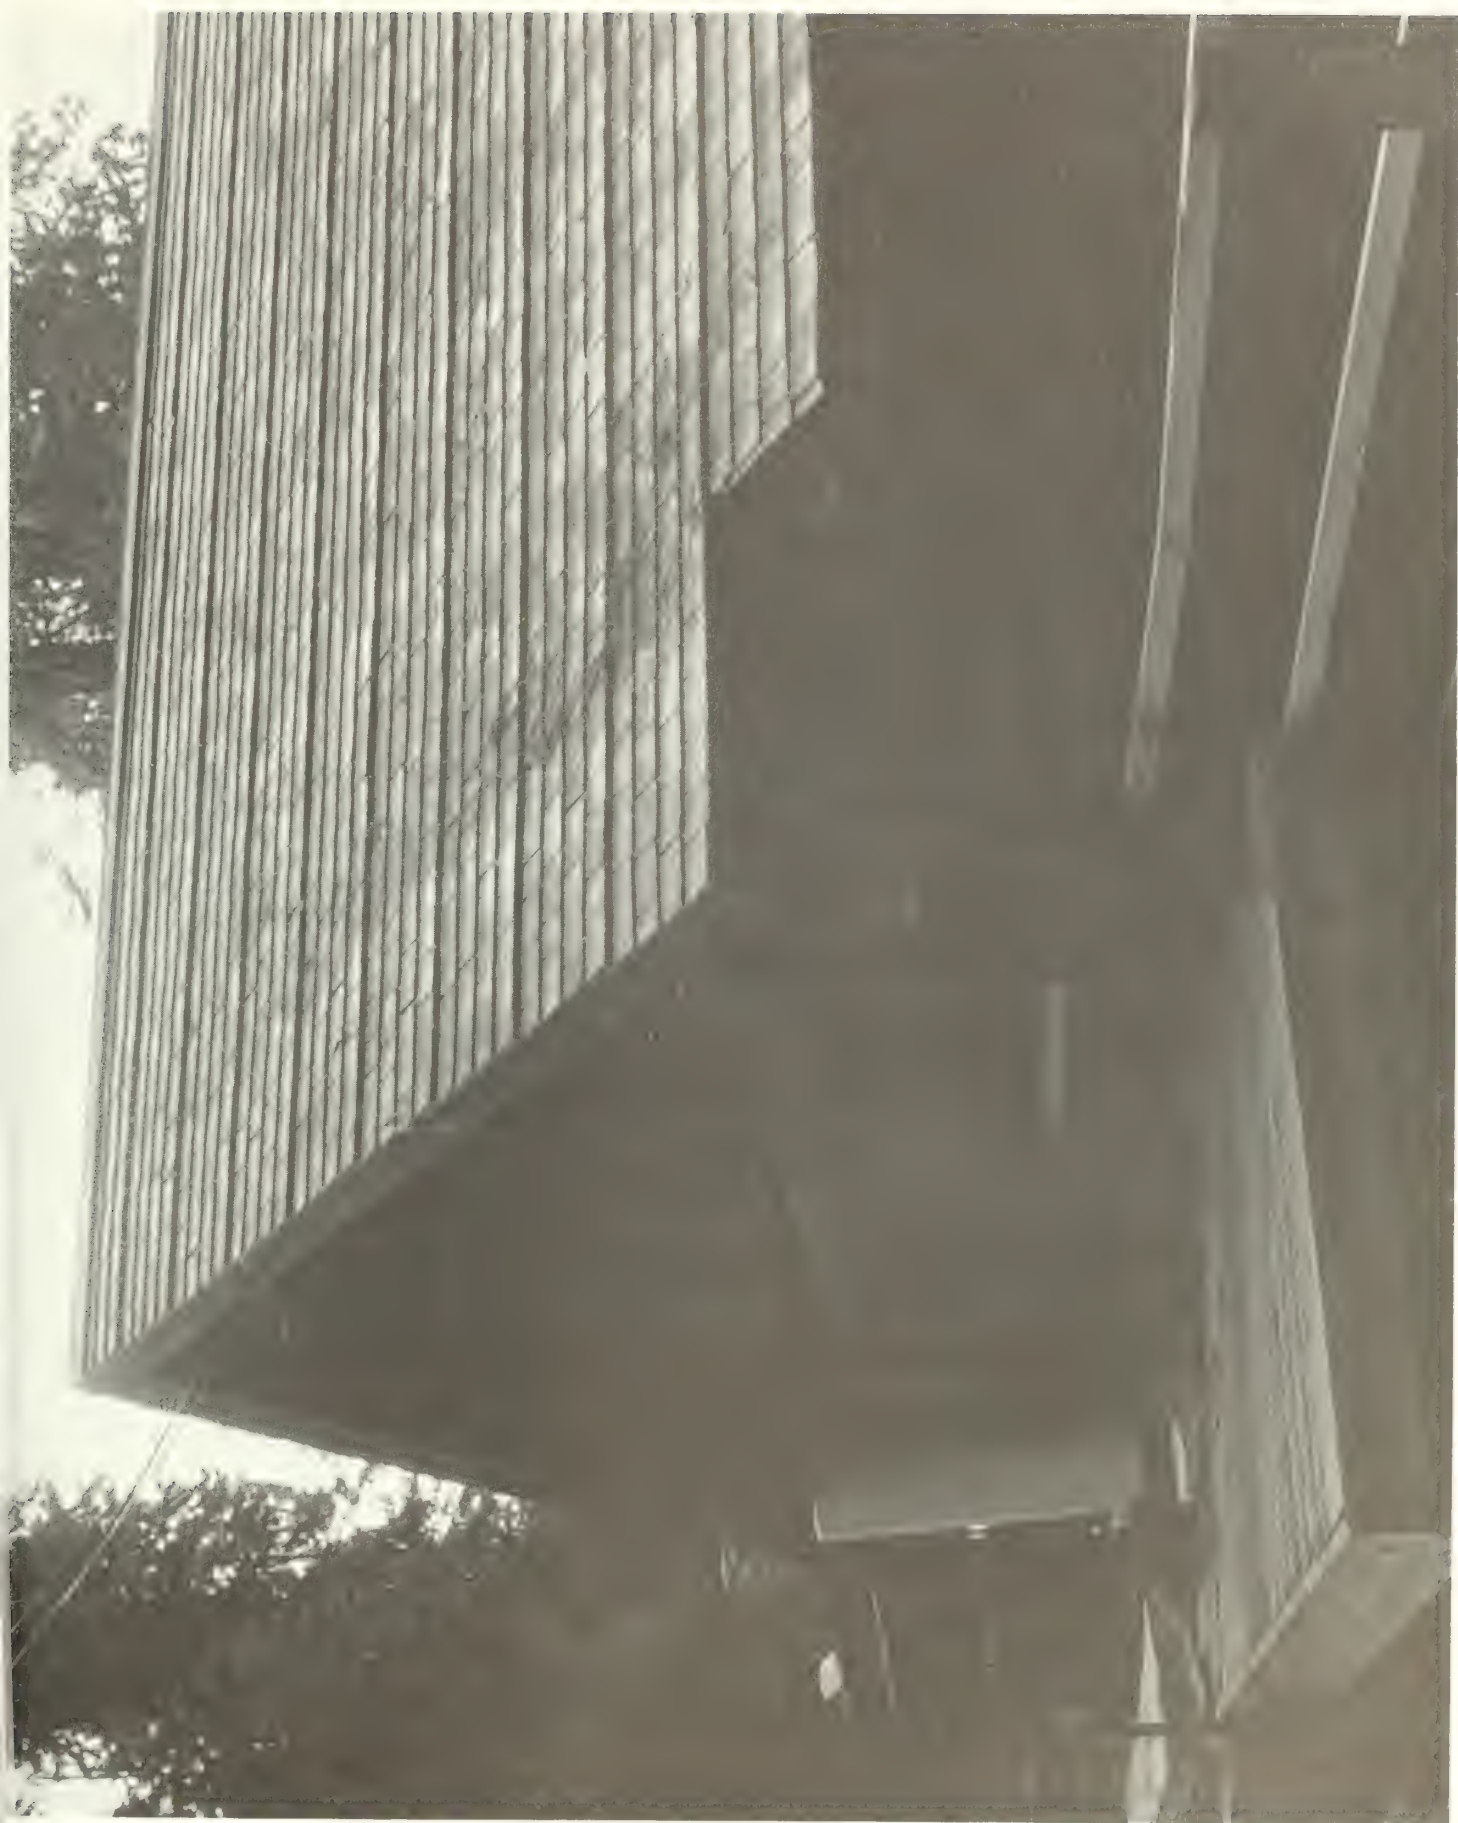
Figure 33. Market from North East (1973). The fifth-course doubled roof pattern is clear in this view of the 1938 north wing addition. Of interest, too, is the wooden loading dock, the hot water heater and the building at far left (ice making house?) which are no longer extant. (Photo by Bill Jones, SEQU archives collection)

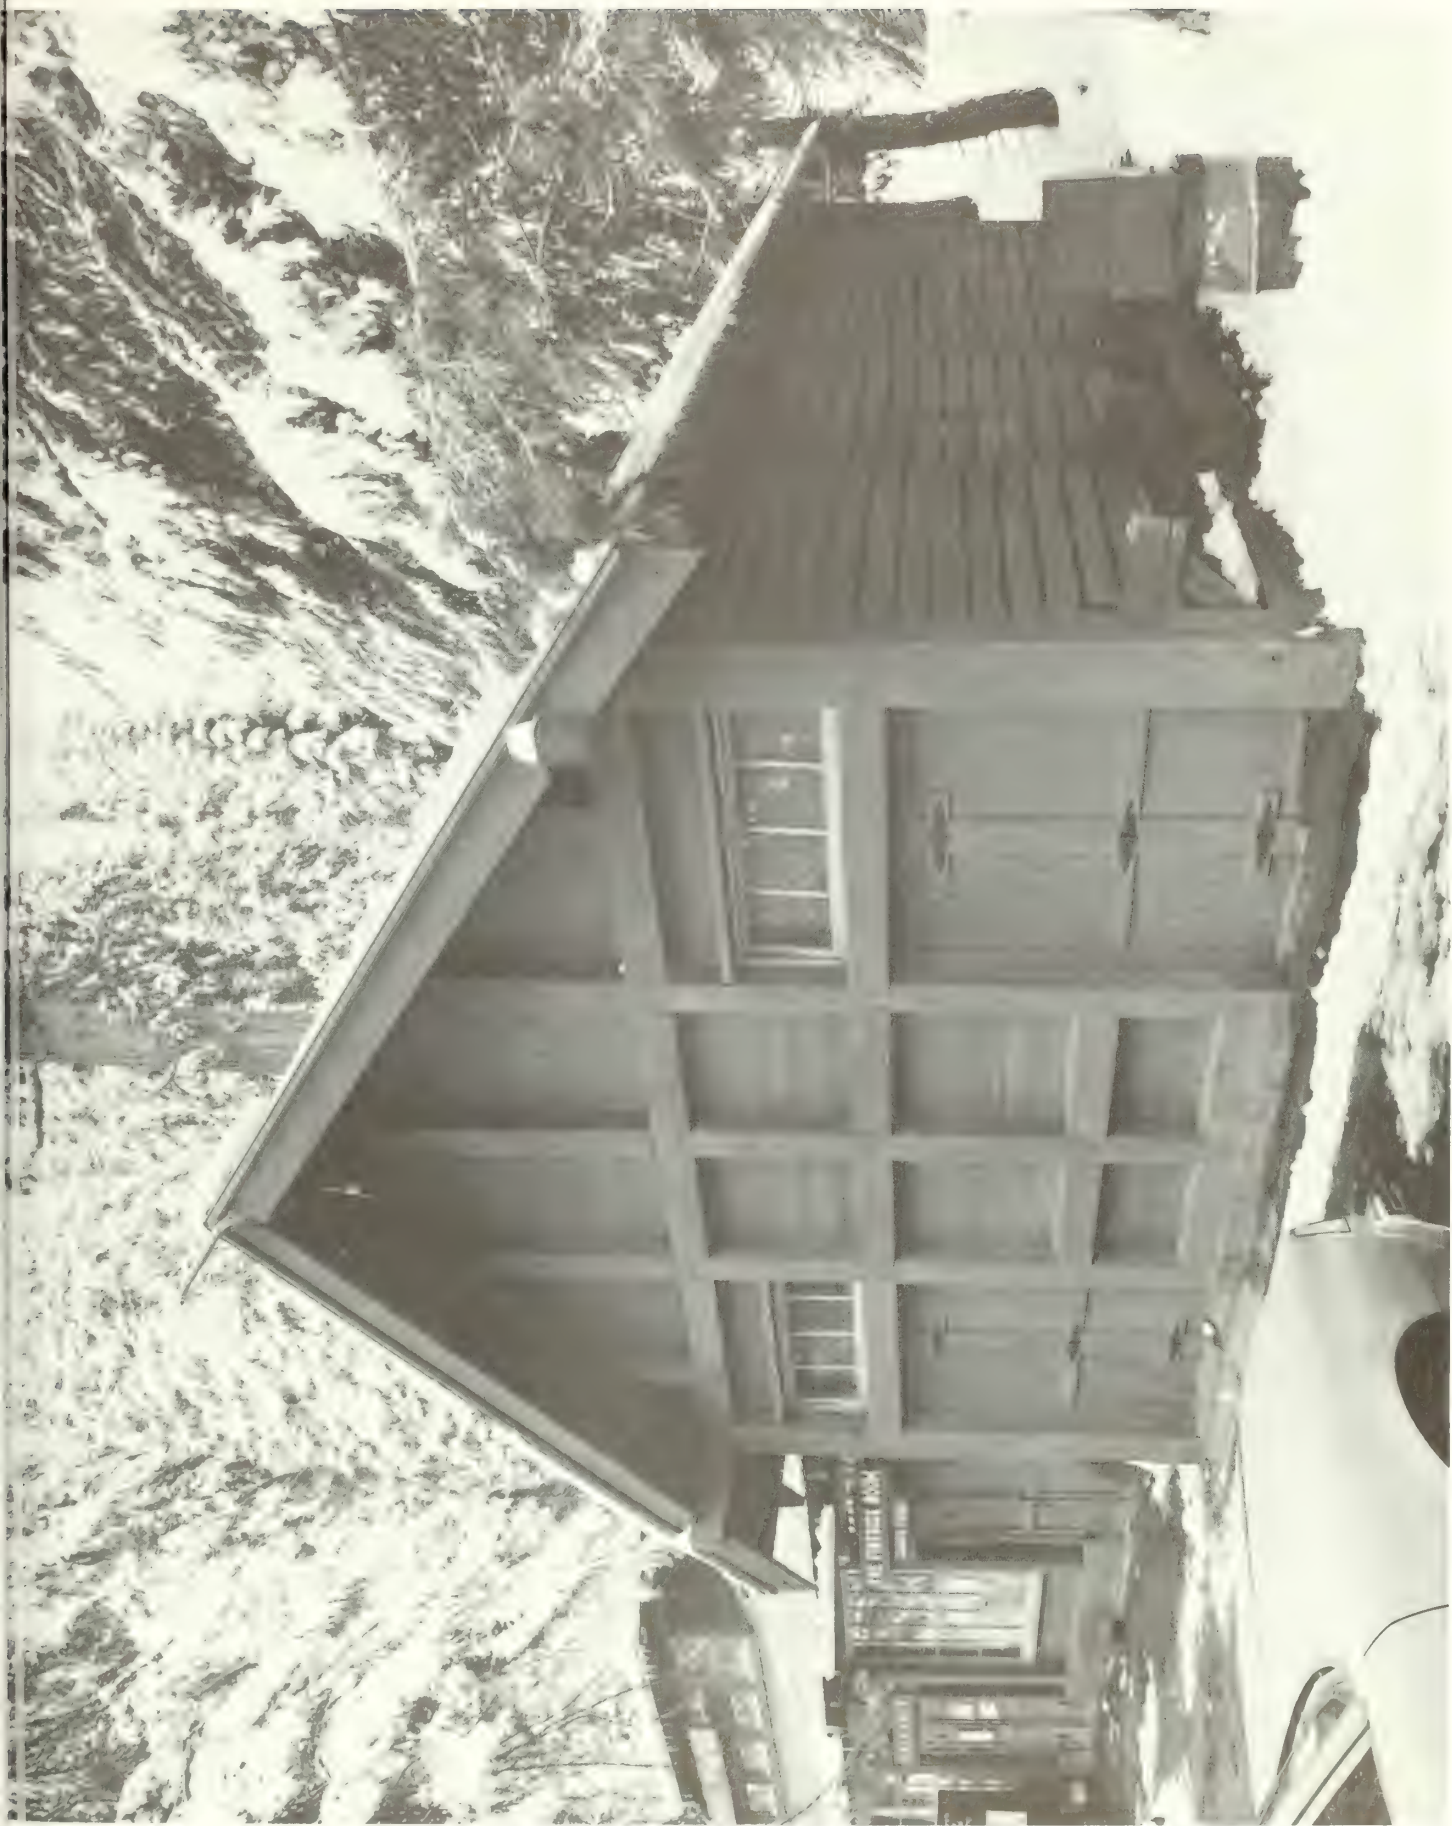
Figure 52. Market, South Wing (ca. 1983). In this winter view of several years ago (prior to the 1983 remodeling of the lounge) boards cover the four large picture windows of the south facade. Neither door in this wing is operable--both are blocked by asphalt at their sills. Notice the doors are center-hinged to fold and open to the full 5 foot width. (HABS #CA2148 B-2)

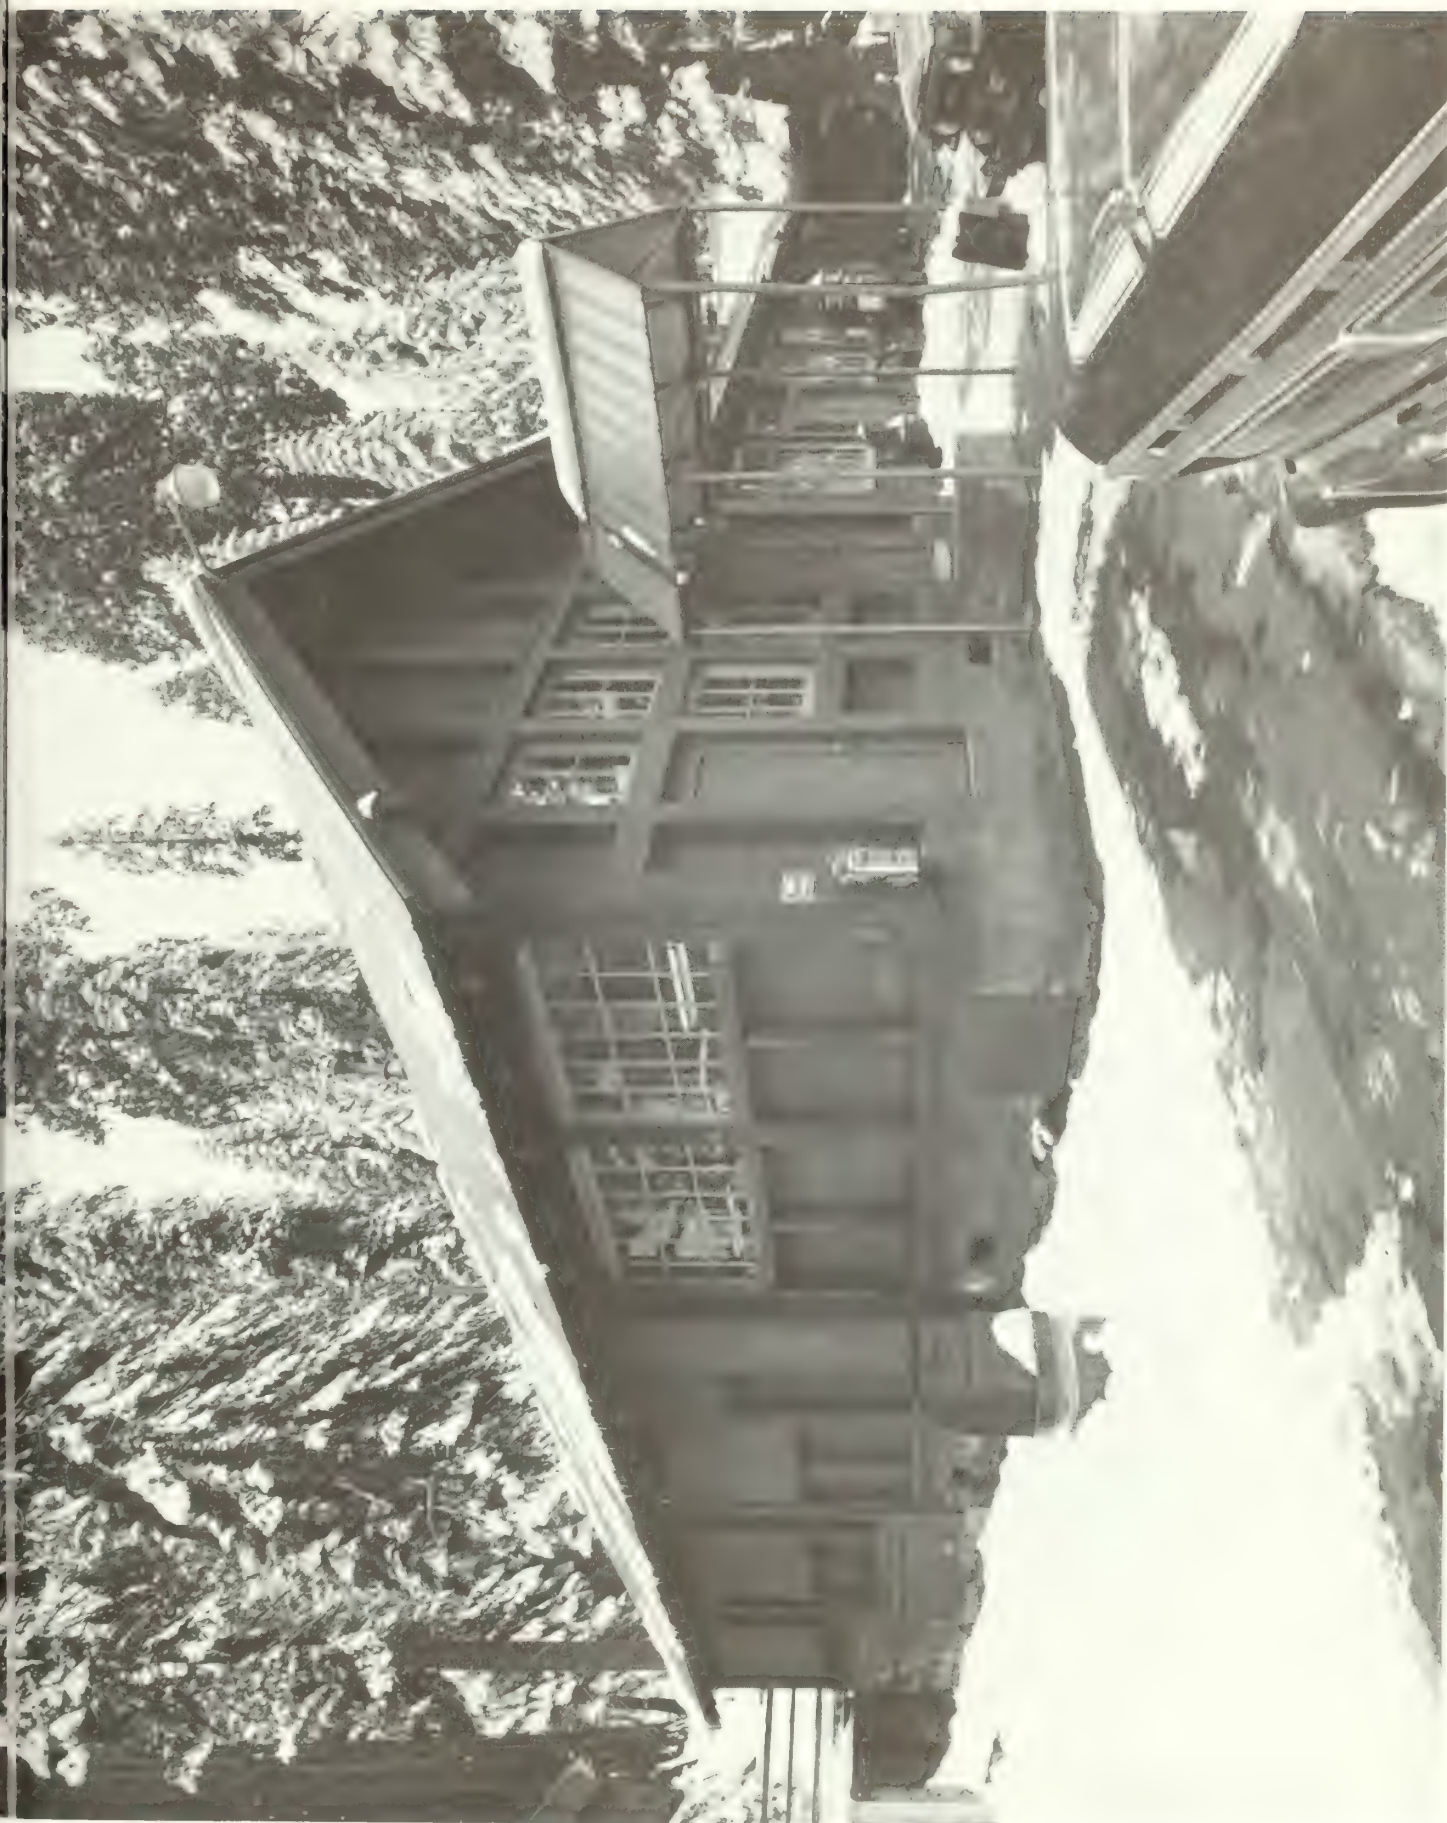
Figure 55. Market, View from North (c. 1983). This photograph provides a clear view of the north facade prior to construction of the existing fence. This view predates the installation of the north wing entry stoop (see figure 53) and, instead, shows a snow canopy protecting the concrete stair entering room 102. The canopy was installed after 1973 and removed about 1984. Note the crawl space vent and crawl space access door. (HABS #CA 2124 B-3).

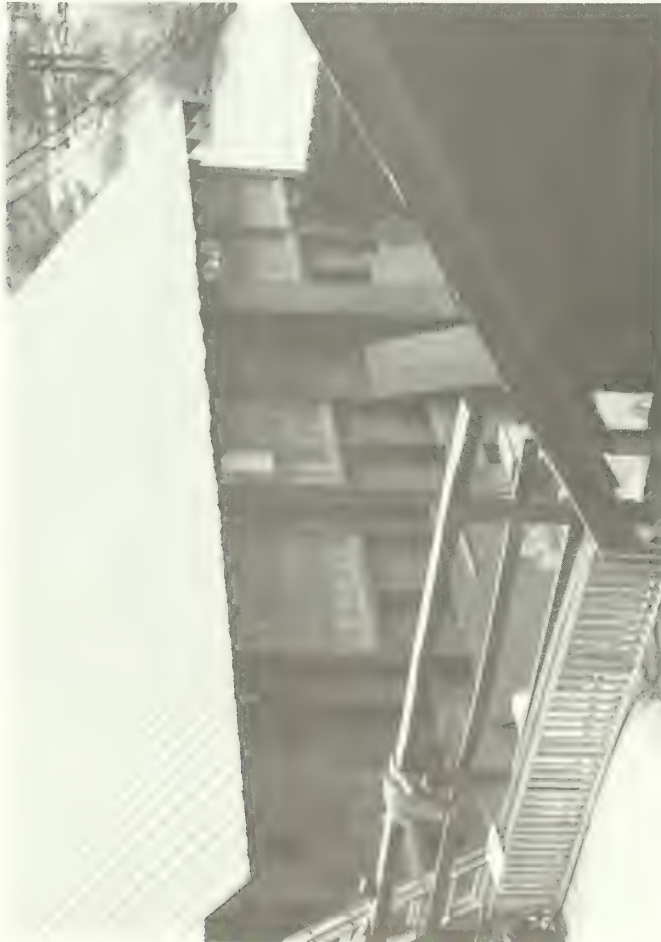
Figure 59 (right). Market, Shed Addition (10/86). The timber frame rhythm of the east elevation of the 1938 shed-roofed addition is, again, entirely compatible with the original building. Wooden panels have been removed, in this view, to expose the windows. Notice the poor condition of the 1975 aluminum sheet roofing. The concrete foundation walls serve as retaining walls and are stepped, following the site contour.

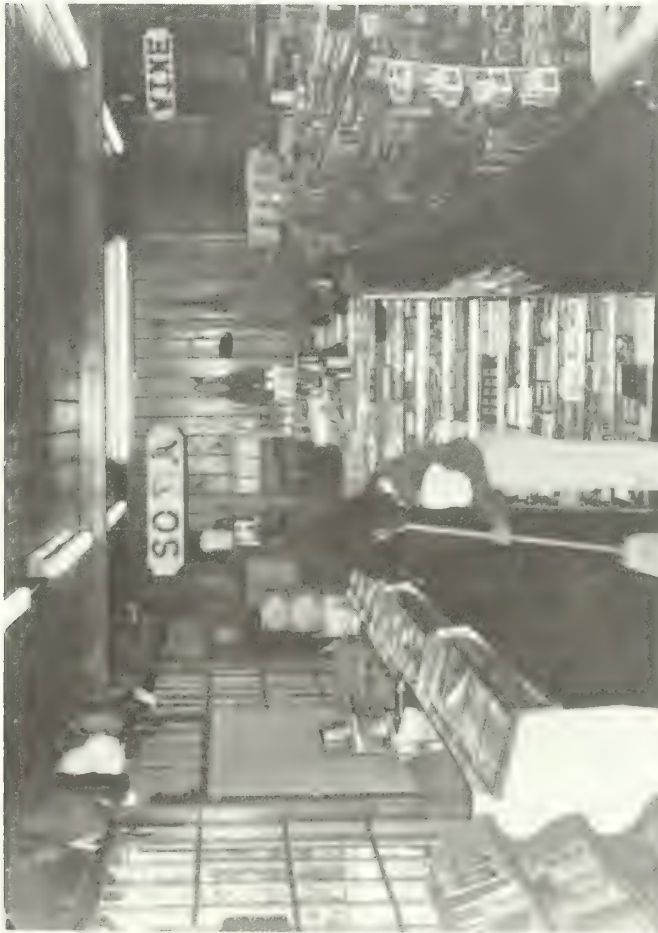
Figure 60 (left). Market, Store Interior (room 101) (5/86). The important impact of the knotty pine on walls and ceiling is clear in this view as is the intrusive and out of character aspect of fluorescent lighting fixtures. The knotty pine was apparently installed in the early 1930s. It is nailed directly to ceiling joists but is firred out against the walls. This view faces north towards room 102.

27) existing lighting is intrusive and incompatible with proposed use ¹⁰ (see figure 60)	27) location of systems is unsatisfactory and fluorescent lights are inappropriate for this historic structure
